P11. Report Citation: Historic Property Survey Report for the Harbor Boulevard North Off-Ramp Project, City of Costa Mesa, Orange County, California, LSA Associates, Inc., January 2006.

*Resource Name or # (Assigned by recorder) Segerstrom Ranch Barn

State of California & The Resources Agency
DEPARTMENT OF PARKS AND RECREATION
DISTRICT RECORD

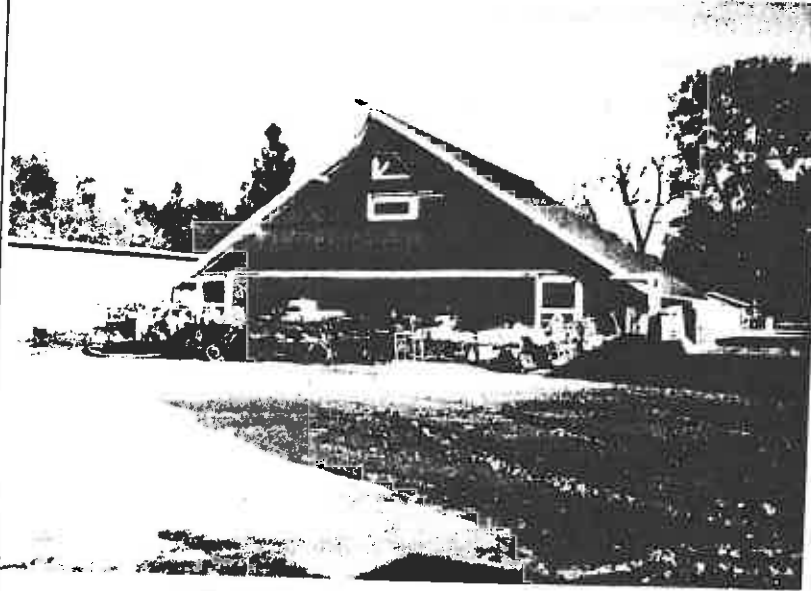
The Segerstrom barn is an excellent example of a Western barn. Contributing features include the vertical wood siding painted red with white trim, low-pitched hanging gable roof, top-hinged horizontal sliding wagon and hayloft doors, and lack of fenestration.

Contributing Barn, view toward northeast

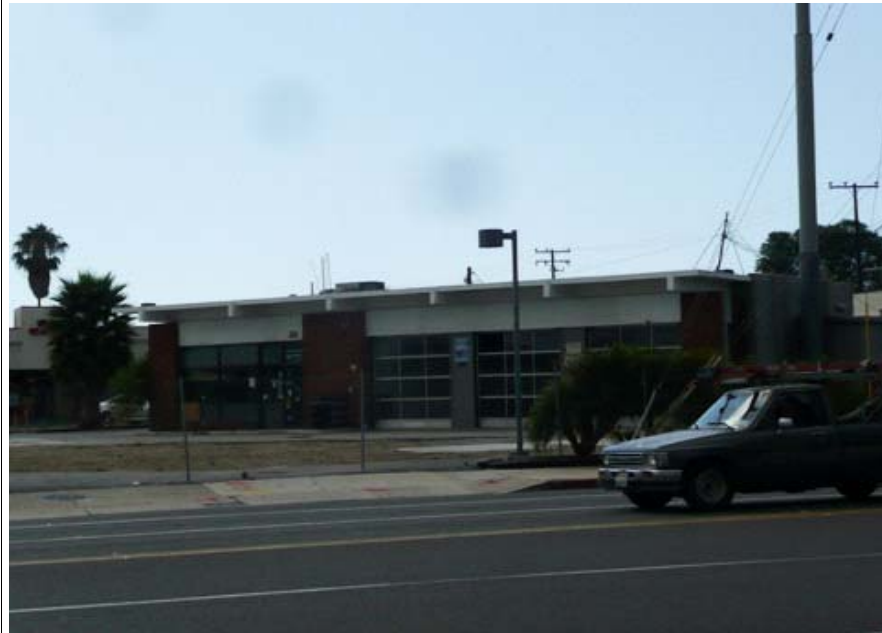
Facing southwest; 10/7/2010; Photo No.
P1040907.jpg

* P3a. Description: (Describe resource and its major elements. Include design, materials, condition, alterations, size, setting, and boundaries.)
The one-story Ranch style commercial building is rectangular in plan. The low-pitched pent roof is clad in composition shingles, and is accented with exaggerated rafter tails. The exterior walls are clad in brick veneer. Three automobile bays, with roll-up doors, are located on the northerly end of the primary (northeast) façade. The southerly bay is characterized by aluminum storefront windows and a pedestrian entrance, which appear to be modern. The building was original constructed as a gas station, and the associated pumps were removed at an unknown date. The building is currently vacant.

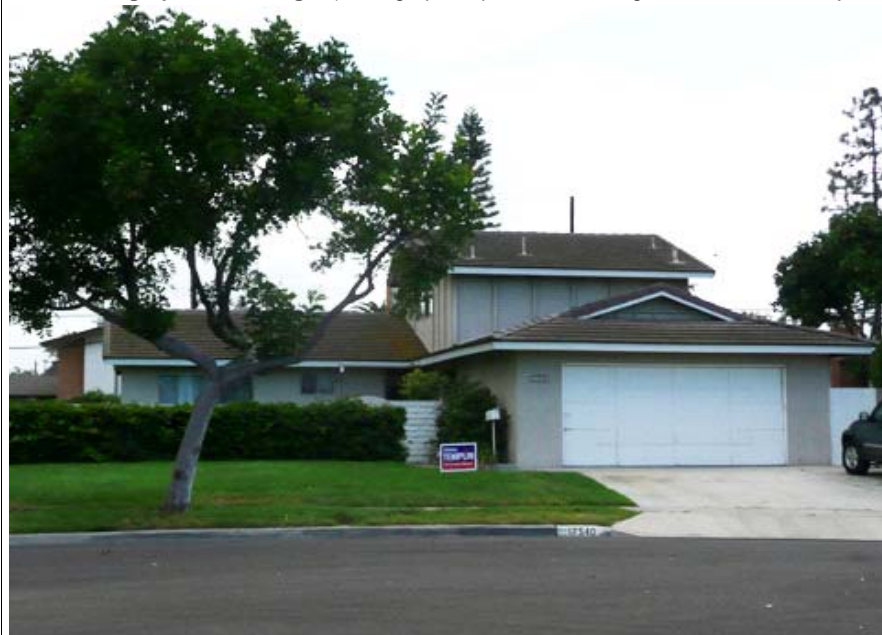
* P3a. Description: (Describe resource and its major elements. Include design, materials, condition, alterations, size, setting, and boundaries.)
Of the 3 parcels of Tract 3995 that are located within the APE, two contained buildings with sufficient integrity to warrant further investigation, which resulted in the subdivision retaining 67 percent integrity. None of the buildings appear to possess sufficient architectural quality as identified in the district record to be considered eligible for listing in the NRHP or the CRHR as individual historic resources or as a historic district.

View of a common Ranch style building found in this district.

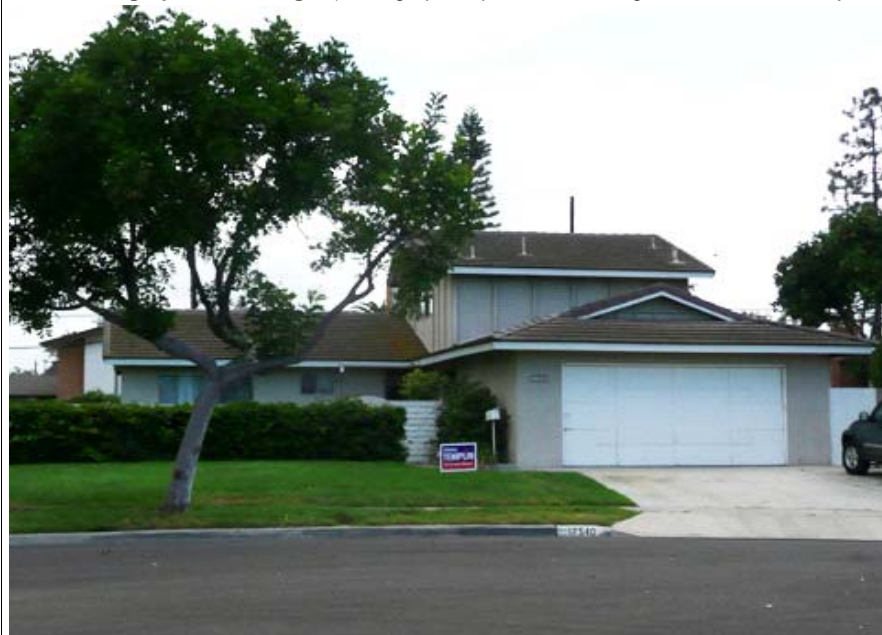
Facing east; 10/7/2010; Photo No.

* P3a. Description: (Describe resource and its major elements. Include design, materials, condition, alterations, size, setting, and boundaries.)
The one-story, with second floor bonus room, Ranch style building is 'L'-shaped in plan. The flared gable on hip roof, with boxed and flared eaves, is clad in composition shingles. The exterior walls are clad in smooth textured stucco and horizontal wood siding with batten. The aluminum sliding and fixed pane windows appear to be original. A brick wall encloses a private courtyard, and obscures additional details of the building. The building does not meet the NRHP and CRHR eligibility criteria for the reasons identified on the district record prepared for this subdivision; therefore the building does not contribute to a historic district and is not individually eligible for listing in the NRHP and the CRHR.

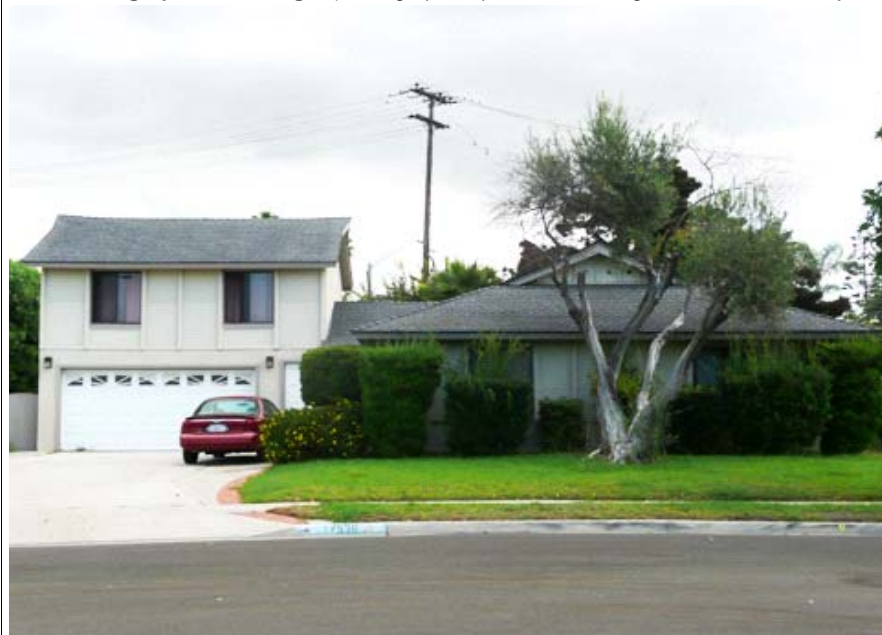
Facing northeast; 10/7/2010; Photo No.
P1040902.jpg

* P3a. Description: (Describe resource and its major elements. Include design, materials, condition, alterations, size, setting, and boundaries.)
The one-story, with second floor bonus room over the garage, Ranch style building is 'L'-shaped in plan. The flared gable on hip roof, with boxed and flared eaves, is clad in composition shingles. The front-facing gable is accented with board and batten siding and a doveote. The exterior walls are clad in smooth textured stucco and horizontal wood siding with batten. The windows have been replaced with modern anodized aluminum sliding units. The primary entrance is recessed and is at grade. Other details are obscured by vegetation. The building does not meet the NRHP and CRHR eligibility criteria for the reasons identified on the district record prepared for this subdivision; therefore the building does not contribute to a historic district and is not individually eligible for listing in the NRHP and the CRHR.

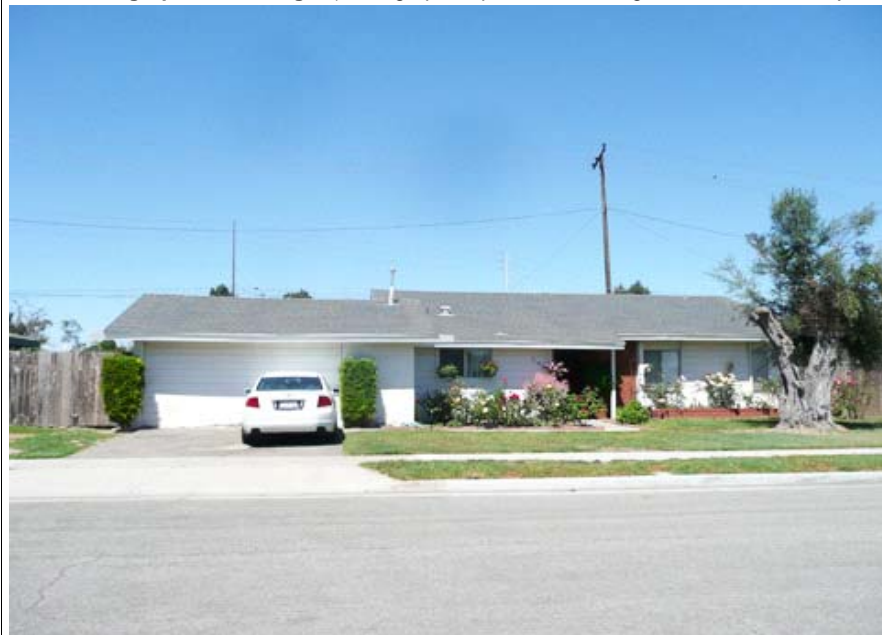
* P3a. Description: (Describe resource and its major elements. Include design, materials, condition, alterations, size, setting, and boundaries.)
Of the 53 parcels of Tract 3995 that are located within the APE, twelve contained buildings with sufficient integrity to warrant further investigation, which resulted in the subdivision retaining 40 percent integrity. None of the buildings appear to possess sufficient architectural quality for the reasons identified in the district record to be considered eligible for listing in the NRHP or the CRHR as individual historic resources or as a historic district.

Detail of an example of Ranch style architecture found in this district.

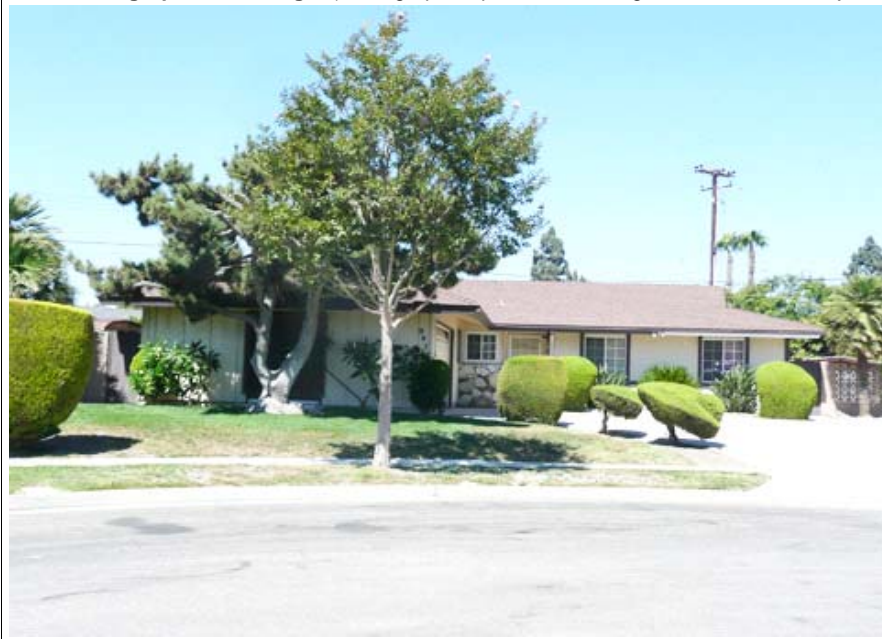
Facing east; 8/19/2010; Photo No.

* P3a. Description: (Describe resource and its major elements. Include design, materials, condition, alterations, size, setting, and boundaries.)
The one-story Ranch style building is 'L'-shaped in plan. The cross gable on hip roof, with boxed and flared eaves, is clad in composition shingles. The exterior walls are clad in vertical board and batten siding, smooth textured stucco, and stone veneer. The windows were replaced with vinyl sliding units at an unknown date, and are accented with wood surrounds. The primary entrance is at grade. A concrete screening block wall demarcates the front and rear yards. The building does not meet the NRHP and CRHR eligibility criteria for the reasons identified on the district record prepared for this subdivision; therefore the building does not contribute to a historic district and is not individually eligible for listing in the NRHP and the CRHR.

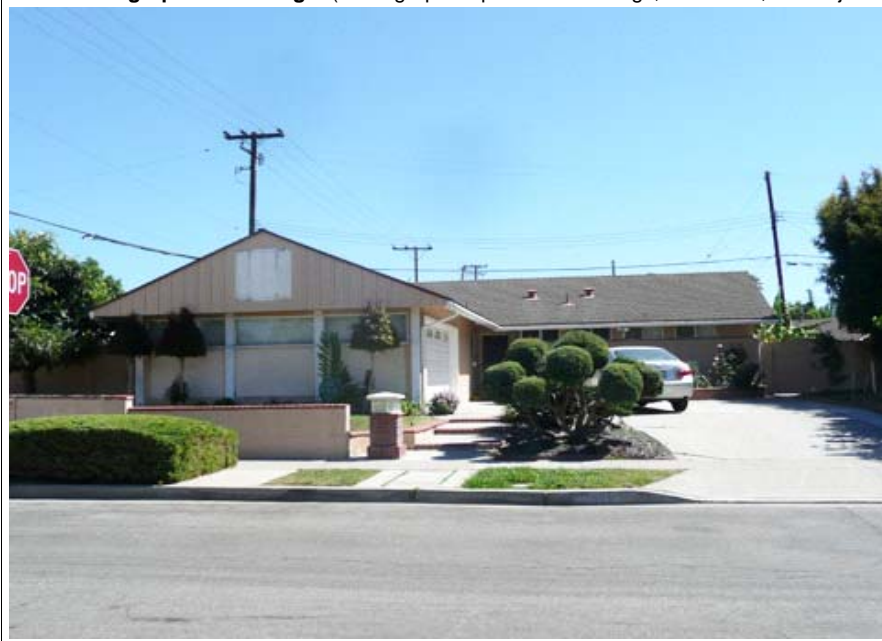
Facing south; 8/19/2010; Photo No.

* P3a. Description: (Describe resource and its major elements. Include design, materials, condition, alterations, size, setting, and boundaries.)
The one-story Ranch style building is 'L'-shaped in plan. The cross gabled roof, with boxed eaves, is clad in composition shingles. The front facing gable is accented with board and batten siding, and an unknown ornamentation appears to have been removed based on a visible scar. The exterior walls are clad in smooth textured stucco and painted brick veneer. Fenestration consists of two bands of windows near the roof line. The band located on the western bay of the primary (northern) façade is characterized by aluminum sliding units, and the ribbon located on the eastern bay of the primary (northern) façade is characterized by fixed-pane windows. The primary entrance is at grade. A low concrete block wall, with brick coping, partially encloses the front yard. The building does not meet the NRHP and CRHR eligibility criteria for the reasons identified on the district record prepared for this subdivision; therefore the building does not contribute to a historic district and is not individually eligible for listing in the NRHP and the CRHR.

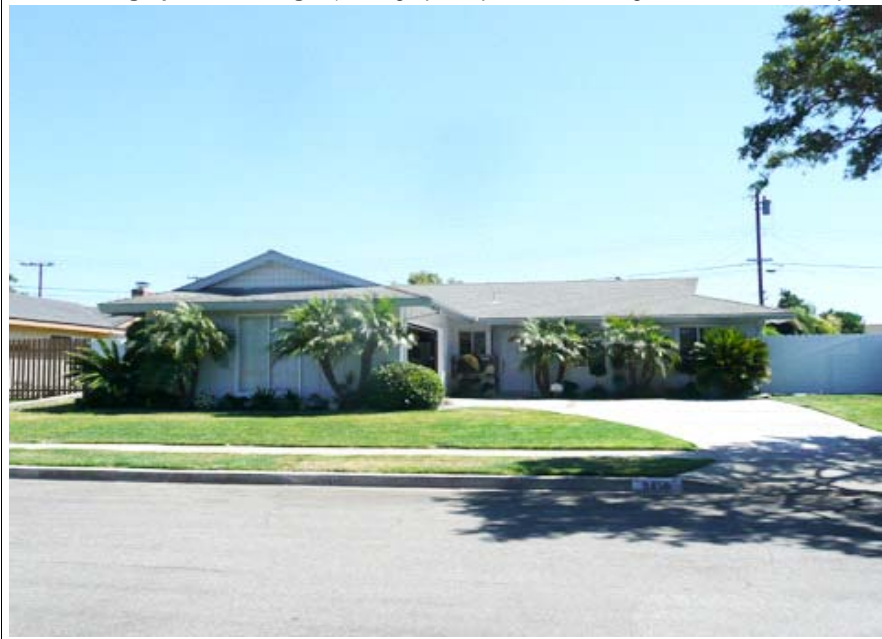
Facing south; 9/18/2010; Photo No.

* P3a. Description: (Describe resource and its major elements. Include design, materials, condition, alterations, size, setting, and boundaries.)
The one-story Ranch style building is 'L'-shaped in plan. The cross gable on hip roof, with boxed and flared eaves, is clad in composition shingles. The gables are accented with lattice false timbering, and the front facing gable is further accented with a minimal dovetail. The exterior walls are clad in smooth textured stucco, with decorative false timbering, and stone veneer. The aluminum sliding and fixed-pane windows appear to be original. The primary entrance is recessed and is at grade. An attached two-car garage projects from the eastern end of the primary (northern) façade. The building does not meet the NRHP and CRHR eligibility criteria for the reasons identified on the district record prepared for this subdivision; therefore the building does not contribute to a historic district and is not individually eligible for listing in the NRHP and the CRHR.

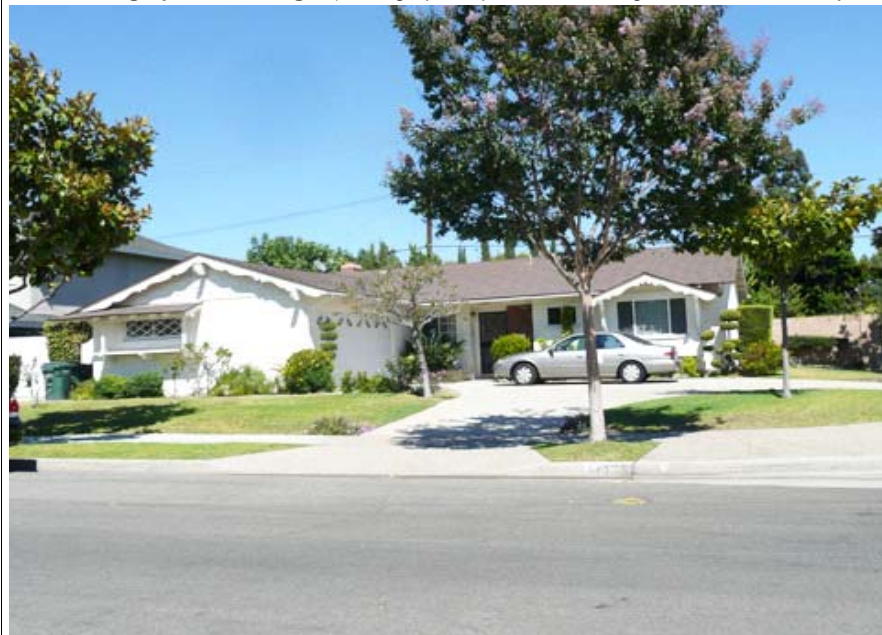
Facing east; 8/19/2010; Photo No.

* P3a. Description: (Describe resource and its major elements. Include design, materials, condition, alterations, size, setting, and boundaries.)
The one-story Ranch style building is 'L'-shaped in plan. The cross gabled roof is clad in composition shingles, and the front-facing gables are accented with scalloped barge board. The northern gable is further accented with scalloped false beams, and the southern bay projects from the primary (western) façade, and is further accented with triangulated knee brackets and corbels. A brick chimney is located on the northern end of the east face of the roof. The exterior walls are clad in smooth textured stucco and brick veneer, with horizontal wood siding in the gables. The windows on the southern bay of the primary (western) façade have been replaced with vinyl sliding units, and are accented with wood surrounds. The window located at the northern end of the projecting garage bay retains its original diamond-paned sliding unit, which is accented with a decorative surround consisting of a ledge, brackets, turned posts, and a pent roof. The primary entrance is raised and recessed. The building does not meet the NRHP and CRHR eligibility criteria for the reasons identified on the district record prepared for this subdivision; therefore the building does not contribute to a historic district and is not individually eligible for listing in the NRHP and the CRHR.

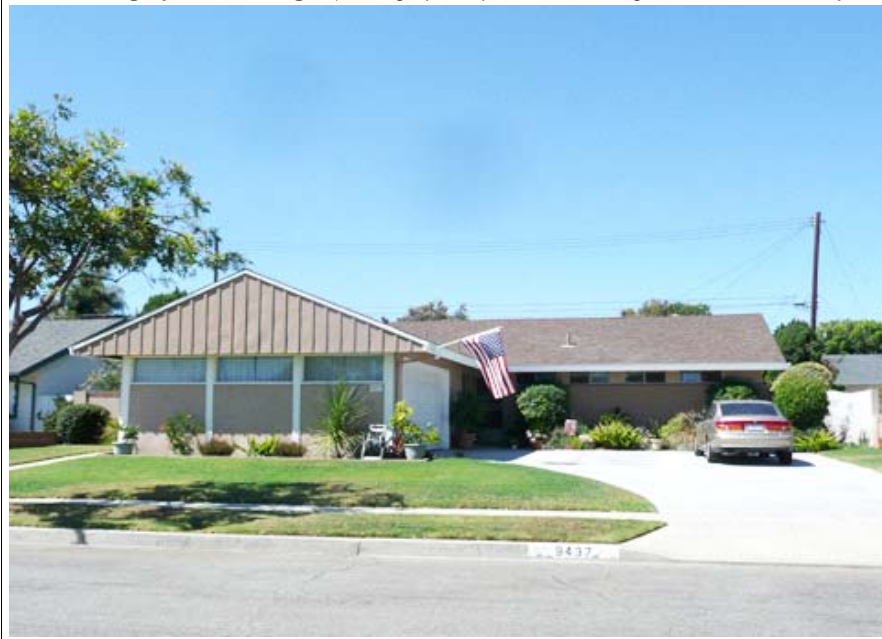
Facing north; 8/19/2010; Photo No.

* P3a. Description: (Describe resource and its major elements. Include design, materials, condition, alterations, size, setting, and boundaries.)
The one-story Ranch style building is 'L'-shaped in plan. The cross gabled roof, with boxed eaves, is clad in composition shingles. The front facing gable is accented with board and batten siding. The exterior walls are clad in smooth textured stucco and painted brick veneer. Fenestration consists of two bands of windows near the roof line. The band located on the western bay of the primary (northern) façade is characterized by aluminum sliding units, and the ribbon located on the eastern bay of the primary (northern) façade is characterized by fixed-pane windows. The primary entrance is at grade. A low concrete block wall, with brick coping, partially encloses the front yard. The building does not meet the NRHP and CRHR eligibility criteria for the reasons identified on the district record prepared for this subdivision; therefore the building does not contribute to a historic district and is not individually eligible for listing in the NRHP and the CRHR.

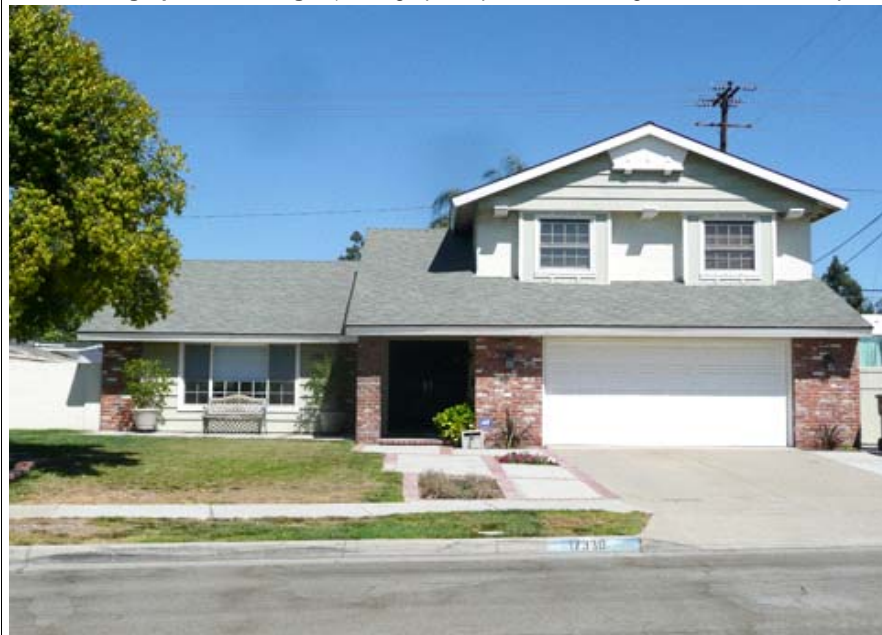
Facing east; 8/19/2010; Photo No.

* P3a. Description: (Describe resource and its major elements. Include design, materials, condition, alterations, size, setting, and boundaries.)
The 1 1/2-story Ranch style building is generally rectangular in plan. The cross gabled roof is clad in composition shingles. The front facing gable is accented with horizontal wood siding, a dove-cote, and corbels. The vinyl sash windows are further accented by wood surrounds which form projecting bays for each window. The exterior walls are clad in smooth textured stucco, horizontal wood siding, and brick veneer. The northern bay of the primary (western) façade is accented with a large fixed-pane vinyl window flanked by vinyl casement windows. The primary entrance is raised, and accessed via a brick veneer clad cast concrete porch. The roof overhangs to shelter the entry porch, and is supported by a brick pier. The building does not meet the NRHP and CRHR eligibility criteria for the reasons identified on the district record prepared for this subdivision; therefore the building does not contribute to a historic district and is not individually eligible for listing in the NRHP and the CRHR.

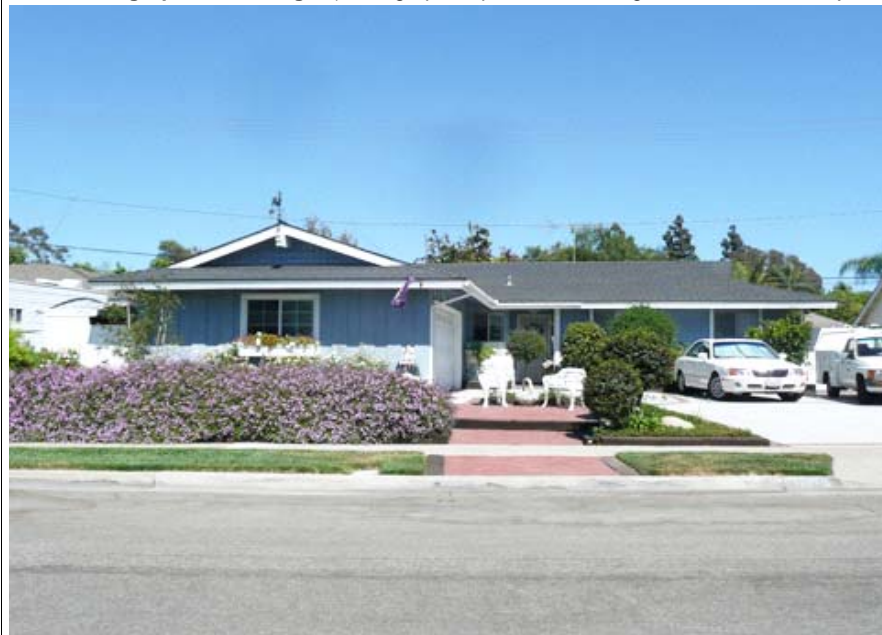
Facing east; 8/19/2010; Photo No.

* P3a. Description: (Describe resource and its major elements. Include design, materials, condition, alterations, size, setting, and boundaries.)
The one-story Ranch style building is 'L'-shaped in plan. The cross gable on hip roof, with boxed eaves, is clad in composition shingles. The front facing gable is accented with lattice false timbering, a notched false beam, and a weathervane. The exterior walls are clad in vertical wood siding and smooth textured stucco. The aluminum sliding windows appear to be original, and are accented with wood surrounds. The window on the west façade of the attached garage has been replaced with a vinyl sliding unit, and is accented with a flower box. The primary entrance is recessed, and is accented with stone veneer to the water line. The building does not meet the NRHP and CRHR eligibility criteria for the reasons identified on the district record prepared for this subdivision; therefore the building does not contribute to a historic district and is not individually eligible for listing in the NRHP and the CRHR.

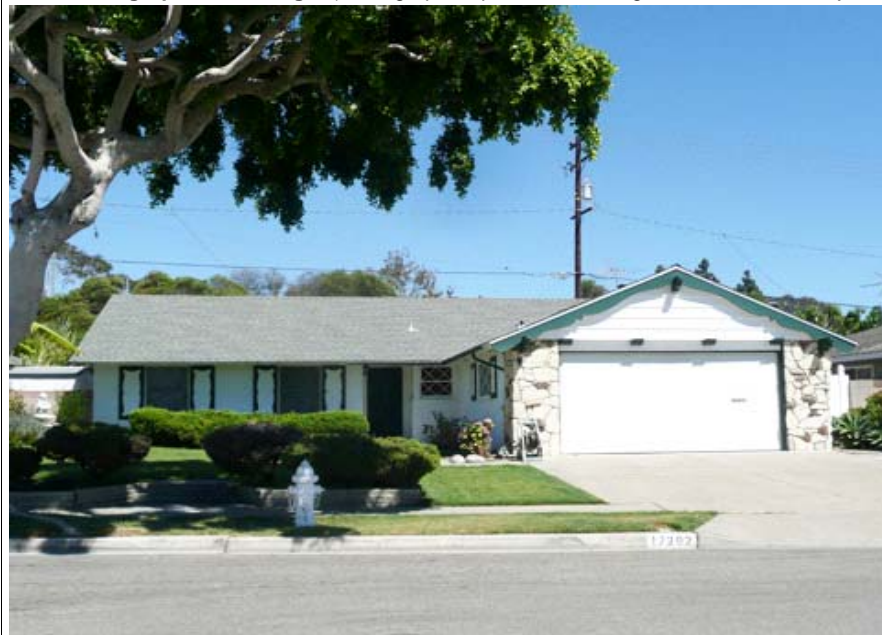
Facing east; 8/19/2010; Photo No.

* P3a. Description: (Describe resource and its major elements. Include design, materials, condition, alterations, size, setting, and boundaries.)
The one-story Ranch style building is 'L'-shaped in plan. The cross gabled roof is clad in composition shingles, and the front facing gable is accented with scalloped barge board, scalloped false beams, horizontal wood siding, and corbels. The exterior walls are clad in smooth textured stucco and stone veneer. The diamond-paned wood sash windows appear to be original, and are accented with shutters. The primary entrance is recessed, and is at grade. The building does not meet the NRHP and CRHR eligibility criteria for the reasons identified on the district record prepared for this subdivision; therefore the building does not contribute to a historic district and is not individually eligible for listing in the NRHP and the CRHR.

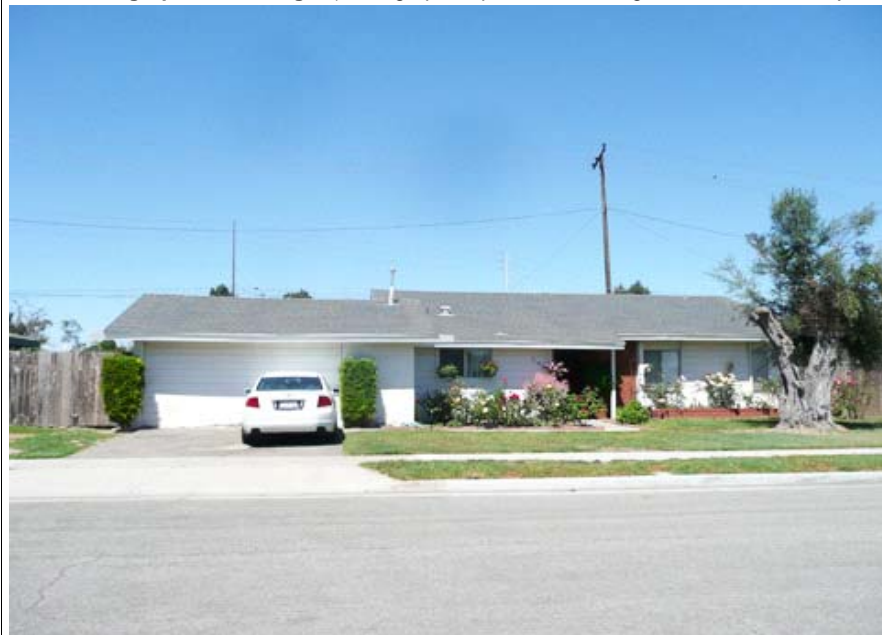
Facing northeast; 8/19/2010; Photo No.

* P3a. Description: (Describe resource and its major elements. Include design, materials, condition, alterations, size, setting, and boundaries.)
The one-story Ranch style building is generally rectangular in plan. The side gabled roof, with boxed eaves, is clad in composition shingles. The exterior walls are clad in horizontal clapboard siding, brick veneer, and smooth textured stucco. The aluminum sliding windows appear to be original, and some windows have been replaced with vinyl sliding units. The primary entrance is recessed. The roof overhangs to shelter the primary entry porch, and is supported by a square wood post. An attached two-car garage, with wood pivot door, is slightly offset from the primary (southwest) façade of the main building, and appears to retain the original wood pivot door. The building does not meet the NRHP and CRHR eligibility criteria for the reasons identified on the district record prepared for this subdivision; therefore the building does not contribute to a historic district and is not individually eligible for listing in the NRHP and the CRHR.

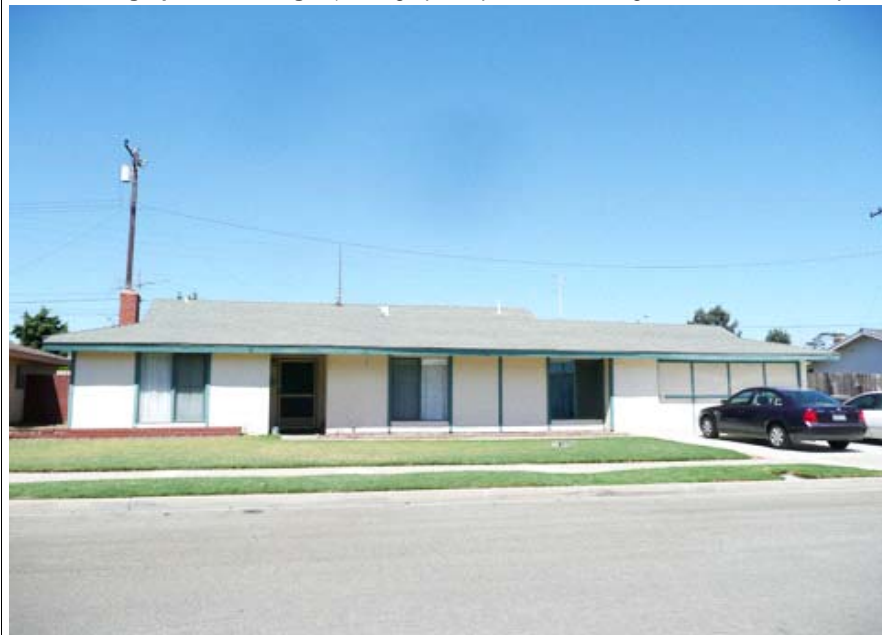
Facing northeast; 8/19/2010; Photo No.

* P3a. Description: (Describe resource and its major elements. Include design, materials, condition, alterations, size, setting, and boundaries.)
The one-story Ranch style building is rectangular in plan. The side gable on hipped roof, with flared and boxed eaves, is clad in composition shingles. A brick chimney is located on the northern elevation of the building. The exterior walls are clad in smooth textured stucco, and is accented with false timbering and corner boards. The fenestration consists of casement and louvered windows, and it is not known if they are original to the building. The primary entrance is recessed and at grade. An attached two-car garage, with wood pivot door, is located on the southern end of the primary (southwestern) façade. The building does not meet the NRHP and CRHR eligibility criteria for the reasons identified on the district record prepared for this subdivision; therefore the building does not contribute to a historic district and is not individually eligible for listing in the NRHP and the CRHR.

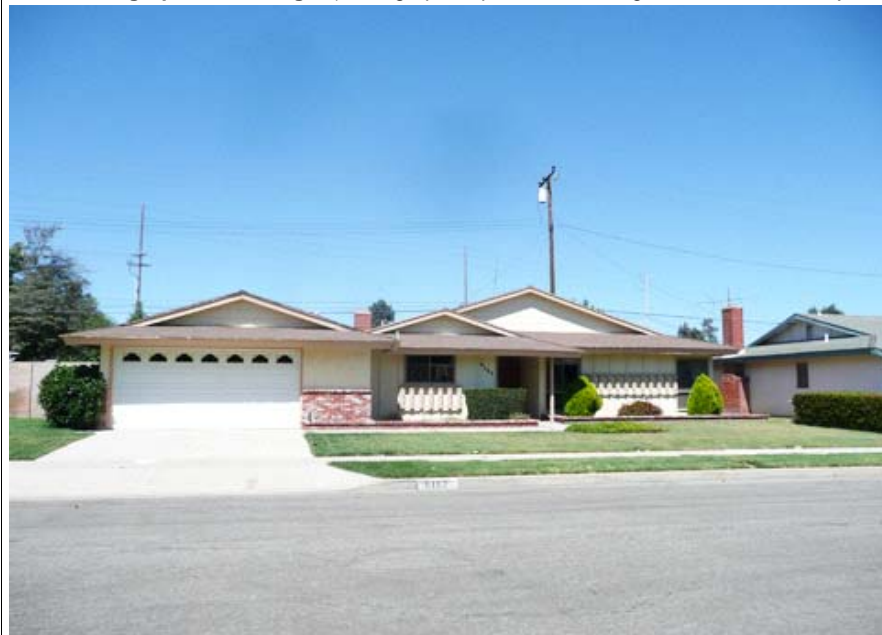
Facing northeast; 8/19/2010; Photo No.

* P3a. Description: (Describe resource and its major elements. Include design, materials, condition, alterations, size, setting, and boundaries.)
The one-story Ranch style building is 'L'-shaped in plan. The cross gable on hip roof, with boxed eaves, is clad in composition shingles. A brick chimney is centrally located on the east face of the roof. The exterior walls are clad in smooth textured stucco with brick veneer to the water line, board and batten siding, and horizontal clapboard siding in the gable. The aluminum sliding and fixed-pane windows appear to be original, and are accented with decorative wood screening, which also spans the eastern end of the primary (southwestern) façade. The primary entrance is recessed, and is accented with brick veneer. An attached two-car garage, slightly projects from the northern end of the primary (southwestern) façade. The building does not meet the NRHP and CRHR eligibility criteria for the reasons identified on the district record prepared for this subdivision; therefore the building does not contribute to a historic district and is not individually eligible for listing in the NRHP and the CRHR.

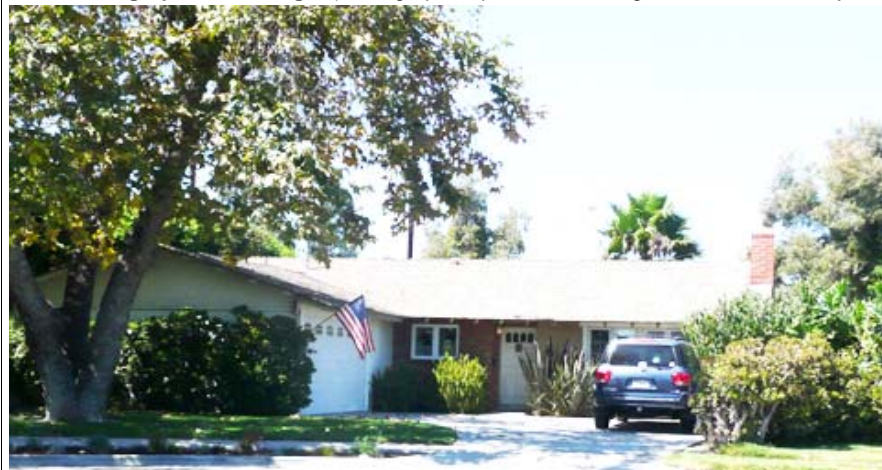
Facing north; 8/19/2010; Photo No.

* P3a. Description: (Describe resource and its major elements. Include design, materials, condition, alterations, size, setting, and boundaries.)
The one-story Ranch style building is 'L'-shaped in plan. The cross gabled roof, with exposed rafter tails, is clad in composition shingles. A brick chimney is located on the eastern elevation of the building. The exterior walls are clad in smooth textured stucco, with horizontal clapboard siding in the gables. The windows were replaced with vinyl sliding and casement units at an unknown date. The primary entrance is raised and is accessed via a small cast concrete porch. The building does not meet the NRHP and CRHR eligibility criteria for the reasons identified on the district record prepared for this subdivision; therefore the building does not contribute to a historic district and is not individually eligible for listing in the NRHP and the CRHR.

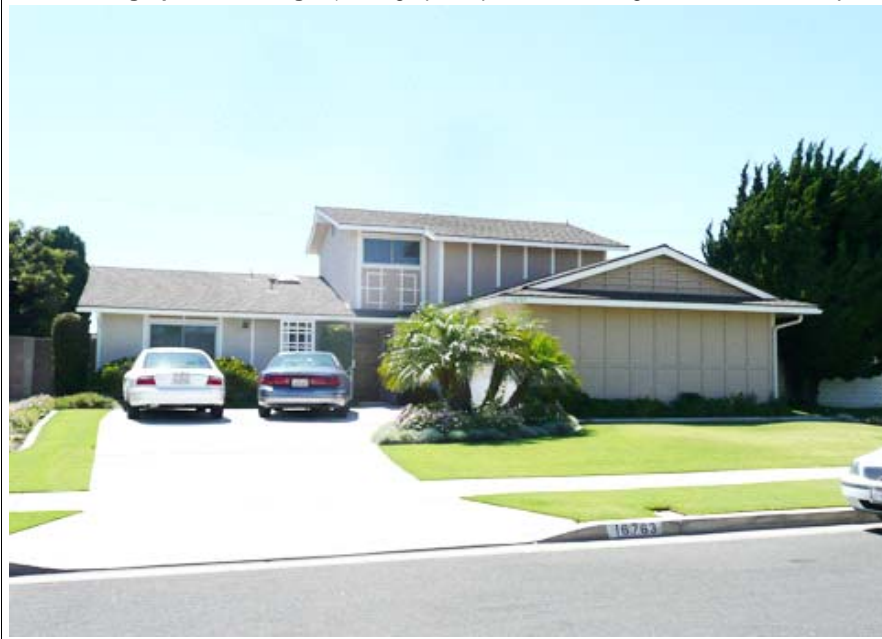
* P3a. Description: (Describe resource and its major elements. Include design, materials, condition, alterations, size, setting, and boundaries.)
Of the 23 lots of Tract 4638, only 7 retained sufficient integrity to warrant further investigation, which resulted in the subdivision retaining 30 percent integrity. None of the buildings appear to possess sufficient architectural quality for the reasons identified on the district record to be considered eligible for listing in the NRHP or the CRHR individually or as a historic district.

View of a representative Ranch style building in this district.

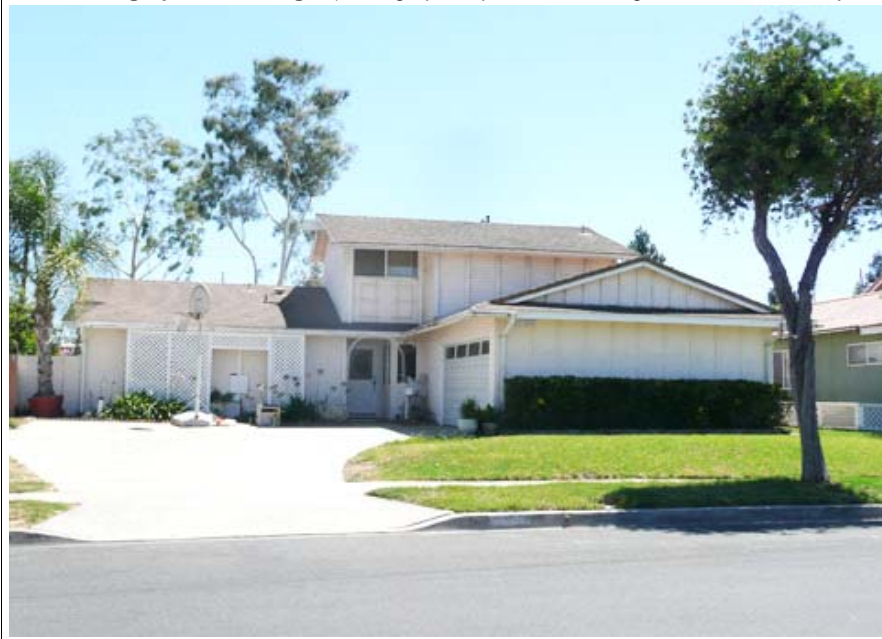
Facing west; 8/19/2010; Photo No.

* P3a. Description: (Describe resource and its major elements. Include design, materials, condition, alterations, size, setting, and boundaries.)
The 1 1/2-story Ranch style building is 'L'-shaped in plan. The side gable and gable on hip roofs, with boxed and flared eaves, are clad in composition shingles. The upper story gables are accented with false beams, and the front facing gable is accented with false timbering. The exterior walls are clad in horizontal clapboard with vertical batten and smooth textured stucco with corner boards. The aluminum sliding windows appear to be original. The window on the upper floor is accented with a spandrel panel with geometric false timbering, and the windows on the southern bay of the primary (eastern) façade are accented with a trellis. The primary entrance is raised and recessed. An attached two-car garage projects from the northern end of the primary (eastern) façade and is accented with false timbering. The building does not meet the NRHP and CRHR eligibility criteria for the reasons identified on the district record prepared for this subdivision; therefore the building does not contribute to a historic district and is not individually eligible for listing in the NRHP and the CRHR.

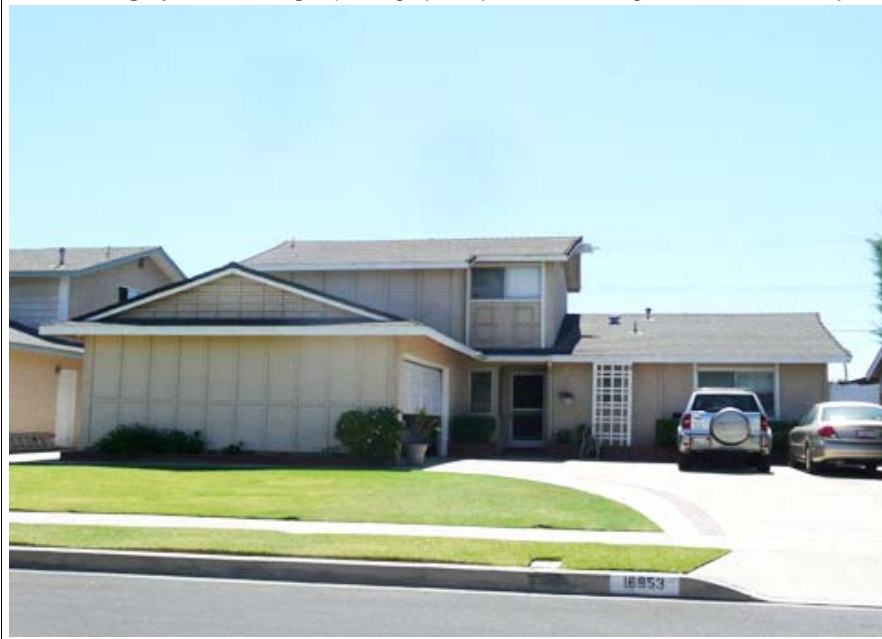
Facing west; 8/19/2010; Photo No.

* P3a. Description: (Describe resource and its major elements. Include design, materials, condition, alterations, size, setting, and boundaries.)
The 1 1/2-story Ranch style building is 'L'-shaped in plan. The side gable and gable on hip roofs, with boxed and flared eaves, are clad in composition shingles. The upper story gables are accented with false beams, and the front facing gable is accented with lattice false timbering. The exterior walls are clad in horizontal clapboard, with vertical batten, smooth textured stucco, and corner boards. The aluminum sliding windows appear to be original. The window on the upper floor is accented with a spandrel panel with geometric false timbering, and the central window on the northern bay of the primary (eastern) façade is accented with a trellis. The primary entrance is recessed and at grade. An attached two-car garage projects from the southern end of the primary (eastern) façade and is accented with false timbering. The building does not meet the NRHP and CRHR eligibility criteria for the reasons identified on the district record prepared for this subdivision; therefore the building does not contribute to a historic district and is not individually eligible for listing in the NRHP and the CRHR.

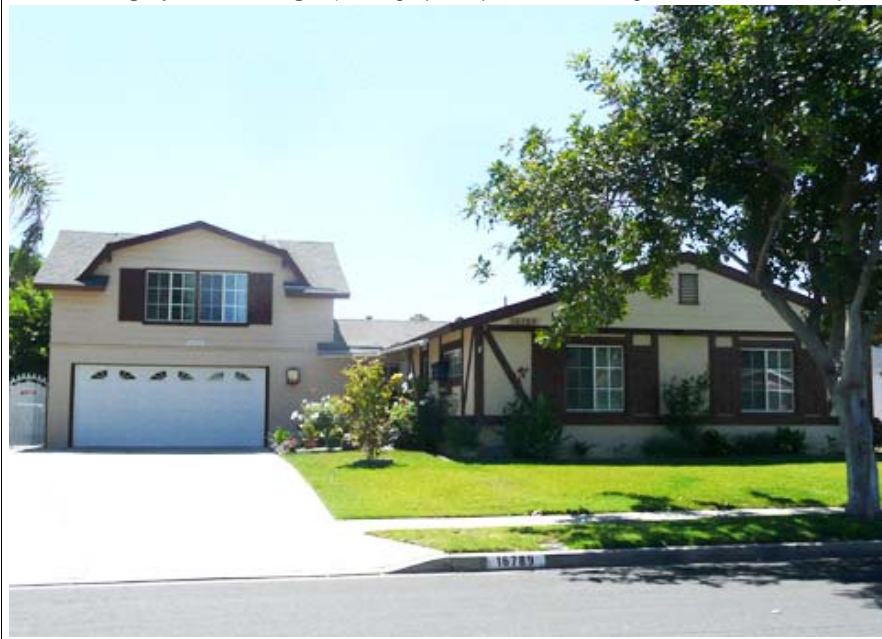
Facing west; 8/19/2010; Photo No.

* P3a. Description: (Describe resource and its major elements. Include design, materials, condition, alterations, size, setting, and boundaries.)
The 1 1/2-story Ranch style building is 'L'-shaped in plan. The cross gabled roof, with boxed eaves, is clad in composition shingles. The front facing gable of the southern bay is accented with a gambrel roof and false beams. The exterior walls are clad in smooth textured stucco walls with false timbering and board band accents, and horizontal wood siding. The gable of the northern bay appears to be clad in coursed asbestos shingles. The windows have been replaced with vinyl sliding units. The primary entrance is recessed. The building does not meet the NRHP and CRHR eligibility criteria for the reasons identified on the district record prepared for this subdivision; therefore the building does not contribute to a historic district and is not individually eligible for listing in the NRHP and the CRHR.

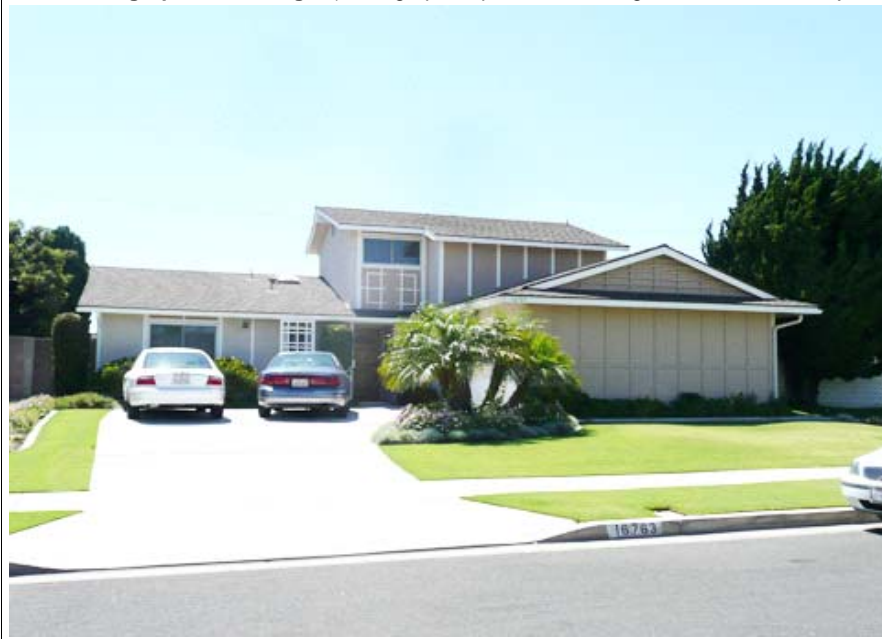
Facing west; 8/19/2010; Photo No.

* P3a. Description: (Describe resource and its major elements. Include design, materials, condition, alterations, size, setting, and boundaries.)
The 1 1/2-story Ranch style building is 'L'-shaped in plan. The side gable and gable on hipped roofs, with boxed and flared eaves, are clad in composition shingles. The front facing gable is accented with false timbering. A bubble skylight is centrally located on the west face of the roof, and it is not known if this is an alteration. The upper floor is largely clad in horizontal clapboard siding with vertical false timbering, and is also clad in smooth textured stucco. The ground floor is clad in smooth textured stucco, which is accented with false timbering and corner boards. The windows appear to have been replaced with modern aluminum sliding windows. A small wood trellis partially shields the central window on the ground floor, and the upper floor window is accented with a spandrel panel containing geometric false timbering. The primary entrance is recessed and at grade. The building does not meet the NRHP and CRHR eligibility criteria for the reasons identified on the district record prepared for this subdivision; therefore the building does not contribute to a historic district and is not individually eligible for listing in the NRHP and the CRHR.

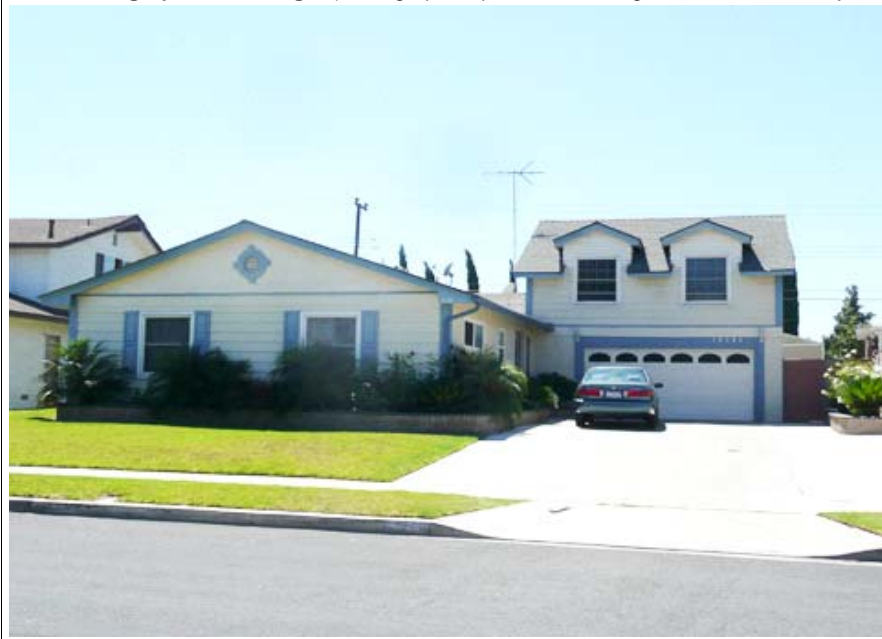
Facing west; 8/19/2010; Photo No.

* P3a. Description: (Describe resource and its major elements. Include design, materials, condition, alterations, size, setting, and boundaries.)
The 1 1/2-story Ranch style building is 'L'-shaped in plan. The cross gabled roofs, with boxed eaves, are clad in composition shingles. The exterior walls are clad in smooth textured stucco and horizontal wood siding, with corner boards. The six-over-six wood sash windows appear to be original, and some windows have been replaced with vinyl sliding units. The windows on the east face of the projecting bay are accented with shutters. The primary entrance is recessed. The building does not meet the NRHP and CRHR eligibility criteria for the reasons identified on the district record prepared for this subdivision; therefore the building does not contribute to a historic district and is not individually eligible for listing in the NRHP and the CRHR.

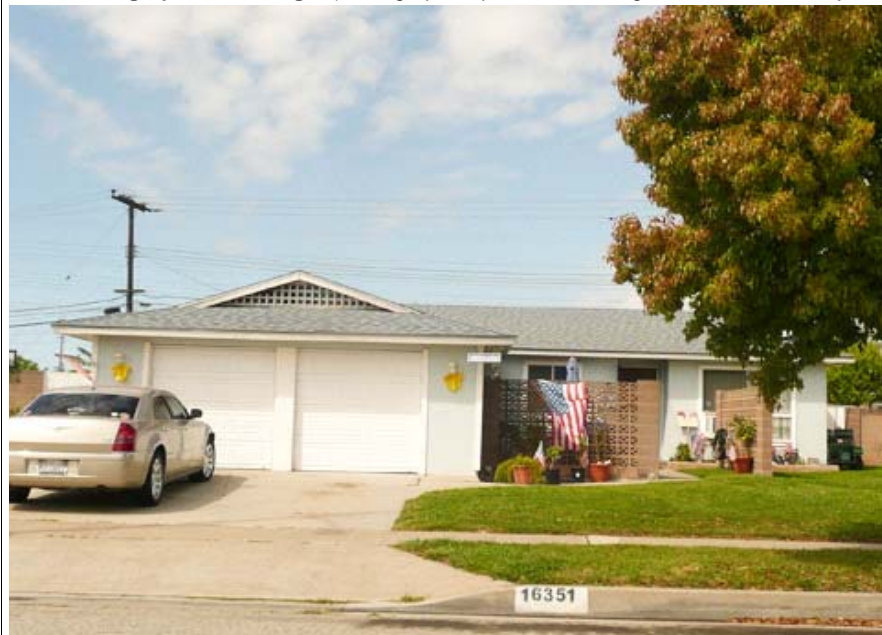
View of a common Ranch style house in Tract 3859.
